TECHNICAL REPORT ARBRL-TR-02567

HANGFIRES, CAUSES, HAZARDS, AND
REMEDIES (CASE STUDY OF XM242
25-MM CHAIN GUN INCIDENT)

James O. Pilcher II

June 1984

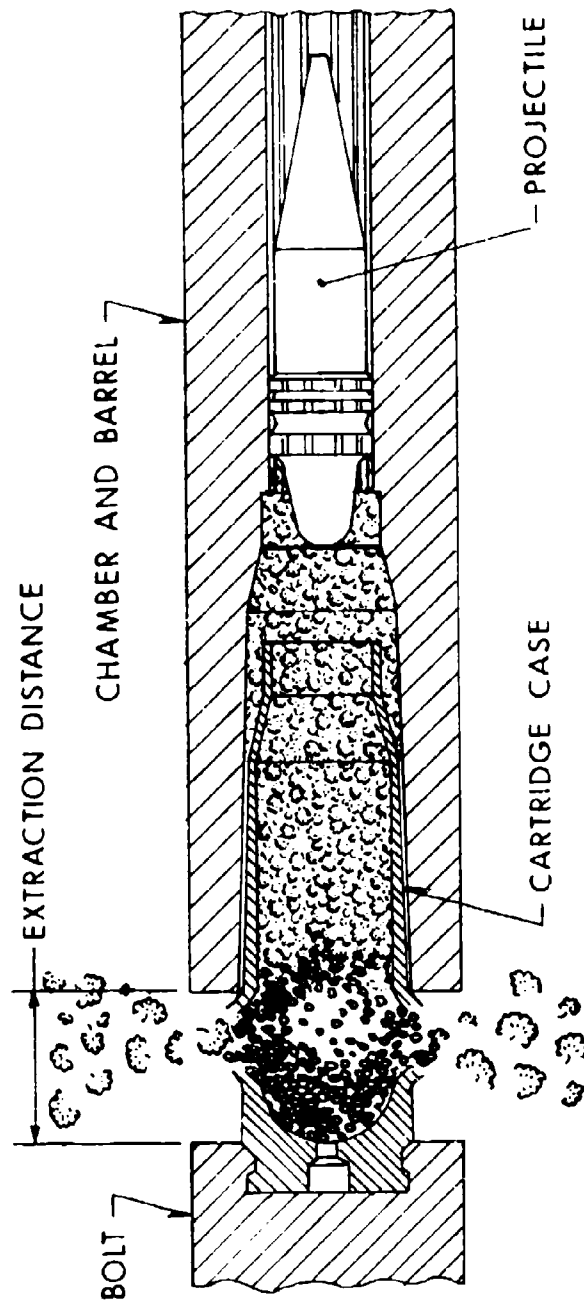
Figure 1. Cartridge Case Rupture During Extraction

The source of the hazards from a hangfire is the potential condition of igniting the propelling charge of the ammunition during the extraction phase of the operating cycle. As the cartridge is removed from the chamber, it loses its constraining support from the chamber walls. The ability of the cartridge case to sustain the propellant pressure is now dependent on the burst strength of the unsupported cartridge case wall. Figure 1 illustrates the condition of ignition during extraction. Figure 2 shows the calculated burst pressure versus extraction distance for the 25-mm TP-T projectile.

In the semiextracted condition, a cartridge case ruptures at pressures corresponding to the distance the cartridge has been extracted prior to ignition. This situation creates three separate conditions.

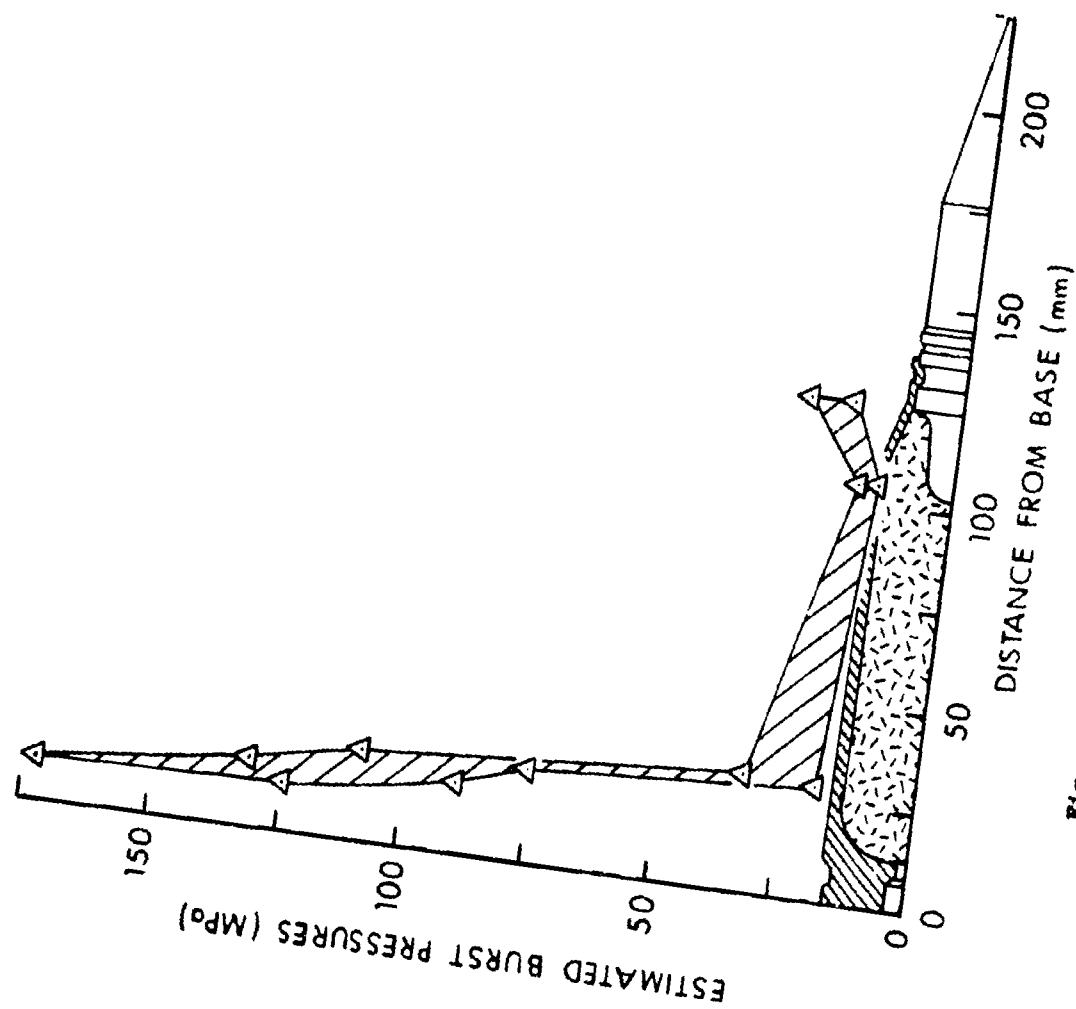
Figure 2. Cartridge Case Burst Pressure

Investigation of the damaged weapon showed that the 25-mm TP-T projectile was initiated during the extraction phase of the operating cycle and that the cartridge case burst when the round had been extracted approximately 19 mm. Calculated estimates of cartridge case burst pressure (shown in Figure 2) indicated that the burst pressure was between 87 and 132 MPa. The damage sustained by the weapon consisted of the bolt carriage assembly being driven into the rear bulkhead of the receiver; the receiver being cracked at the juncture of the rear and bottom walls; and the feed mechanism, feed cover and ejection chute being damaged by the blast and fragments. A pin from the bolt carrier assembly was found loose in the bottom of the receiver and was considered to be a possible cause of the hangfire. The gun was rendered unserviceable.

Based on burst pressure calculations for the cartridge (shown in Figure 2) a worst case condition could possibly cause the rear bulkhead of the receiver to be blown completely free of the weapon.

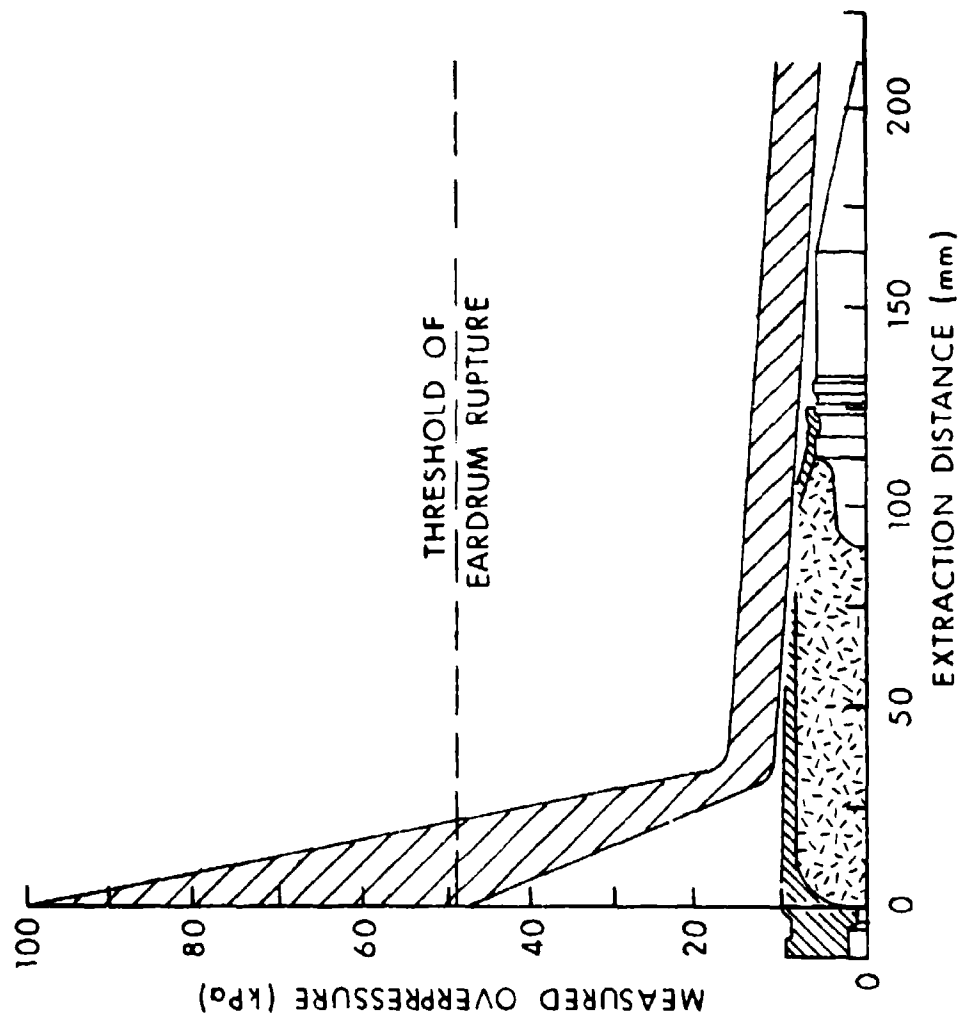
Figure 3. Blast Overpressure at Gunner's Position

The blast effects associated with the rupturing cartridge case present a hazard to both gun and gunner. Figure 3 shows the overpressure measured at the gunner position during a series of failure replication tests performed by Hughes Helicopter Inc.¹

These overpressures are dependent on the amount of free volume around the weapon, the available energy in the propellant, and the burst pressure. In this case, damage to adjacent gun components due to blast ranged from insignificant at low pressures to catastrophic at higher pressures. The higher pressures were on the threshold of eardrum rupture based on the data reported by I.G. Bowen, E.R. Fletcher and D.R. Richmond.² Although incapacitation of the gunner appears to be minimal in this case, one can expect more severe effects from larger caliber weapons because of the increases in available energy.

A series of tests was performed to replicate the incident and establish the hazards generated. The results were that the weapon structure confined all of the fragmentation and potential flying parts; the blast pressure at the gunner's station was as shown in Figure 3. In the worst case the peak blast pressures were on the threshold of eardrum rupture conditions.

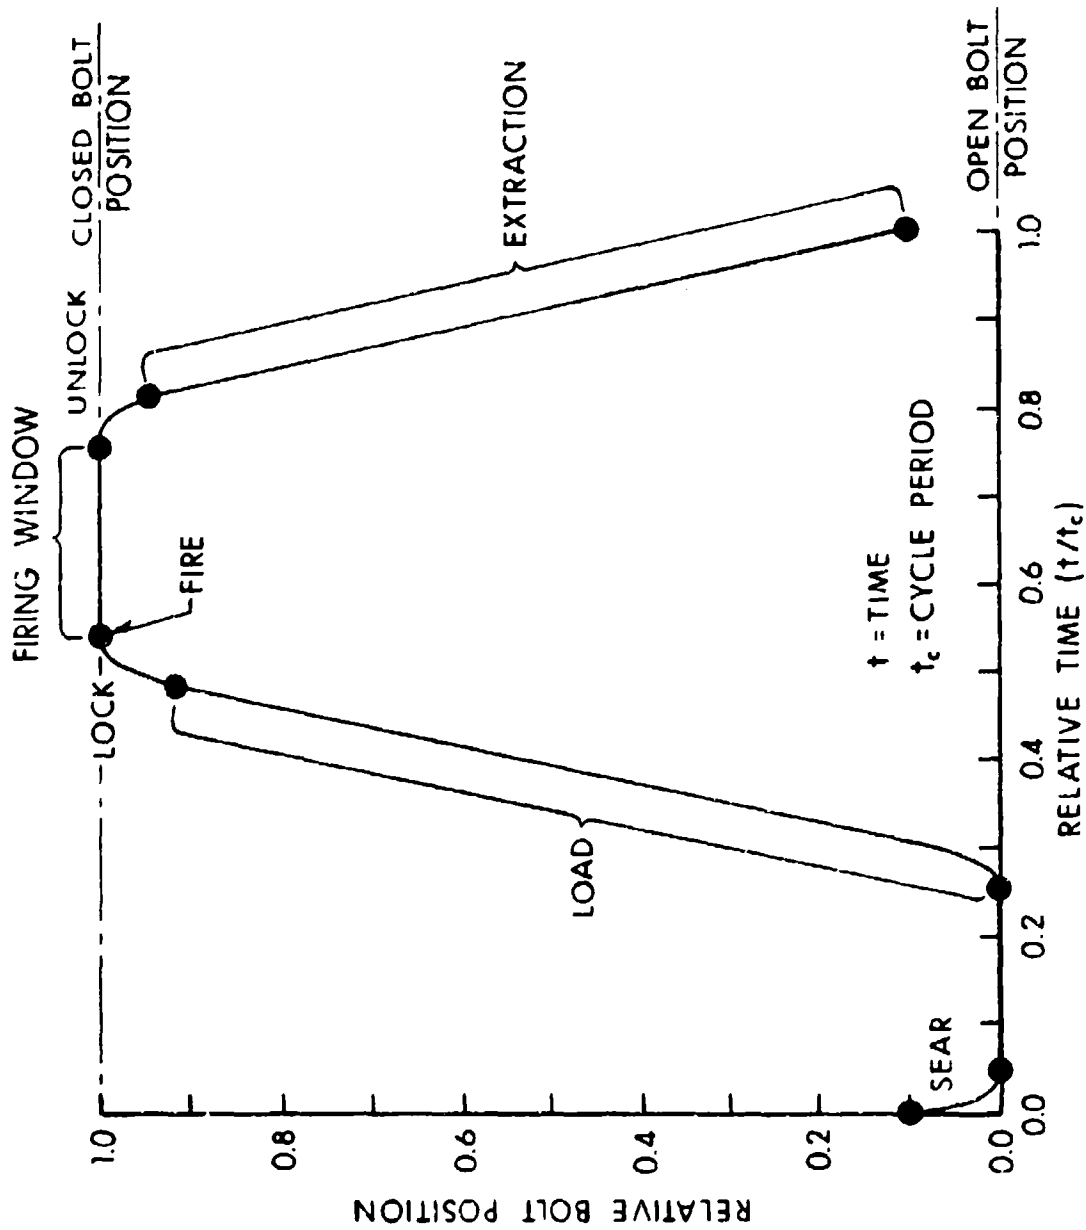
Figure 4. Operating Cycle of M242

Examination of the operating cycle for the gun, which is shown in Figure 4, showed that a 17 millisecond window was available for the ammunition to function. All rounds functioning outside this window represented a potential repeat of the experienced incident. Experimental data from Lake City Army Ammunition Plant showed that one out of ten hangfires would function outside the allowable window.* For a nominally functioning weapon/ammunition system the overall probability of a reoccurrence of the incident is 1×10^{-6} . Data from experiments that examined the effect of flawed ammunition showed that the maximum delay was less than 300 milliseconds and that delays beyond that time were misfires. Figure 5 shows the relationship of hangfire delays with respect to the normal 600 rounds/min and 200 rounds/min firing window.

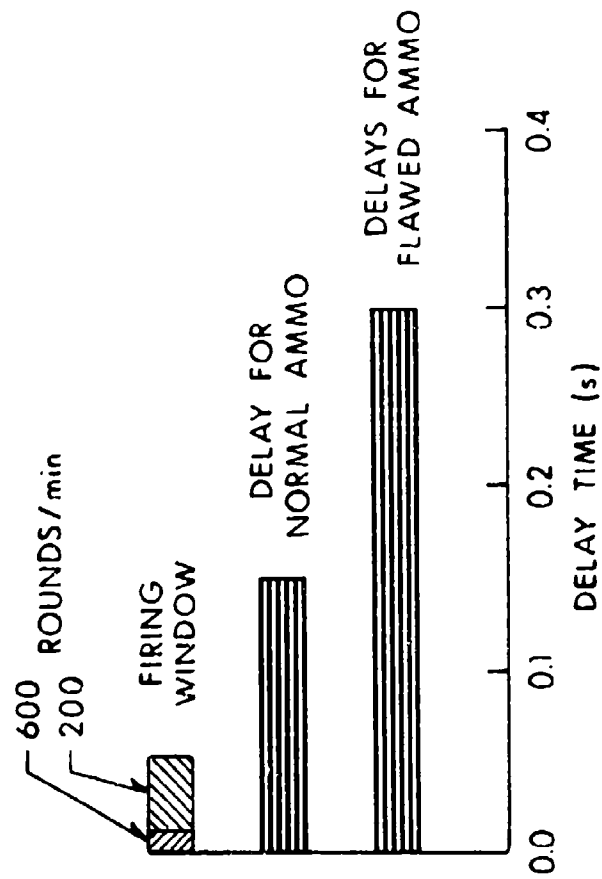
Figure 5. Comparison of Firing Window with Hangfire Delays

Hangfire data for the ammunition showed that the delay times for the ammunition hangfire reached a maximum of 150 milliseconds. For nominally acceptable ammunition with sufficient firing-pin energy, the probability of a hangfire is 1×10^{-5} .

1. Minimizing the Occurrence of Hangfires. In order to minimize the occurrence of hangfires, the bolt/carriage assembly was modified to provide 1) a higher firing-pin striking energy of 42 inch-pounds, and 2) the bolt retaining pin was redesigned to prevent the possibility of it becoming lodged in the mechanism and restricting firing pin motion. These design changes effectively reduce the probability of occurrence of a hazardous hangfire to that of the ammunition, namely, 1×10^{-6} .
